POTENTIAL HAZARDOUS WASTE SITE
SITE INSPECTION REPORT

A. SITE NAME Southern California Chemical Co., Inc.
B. STREET (or other identifier) 1000 N. First St.
C. CITY Garland TX D. STATE TX E. ZIP CODE 75040 F. COUNTY NAME Dallas

Company reclaims spent etching solution from the electronics industry & blends industrial chemicals

1. NAME Robert H. Davis, Jr. 2. TITLE Staff Engineer
3. ORGANIZATION Engineering-Science, Inc. 4. TELEPHONE NO. (area code & no.) (512) 477-9901

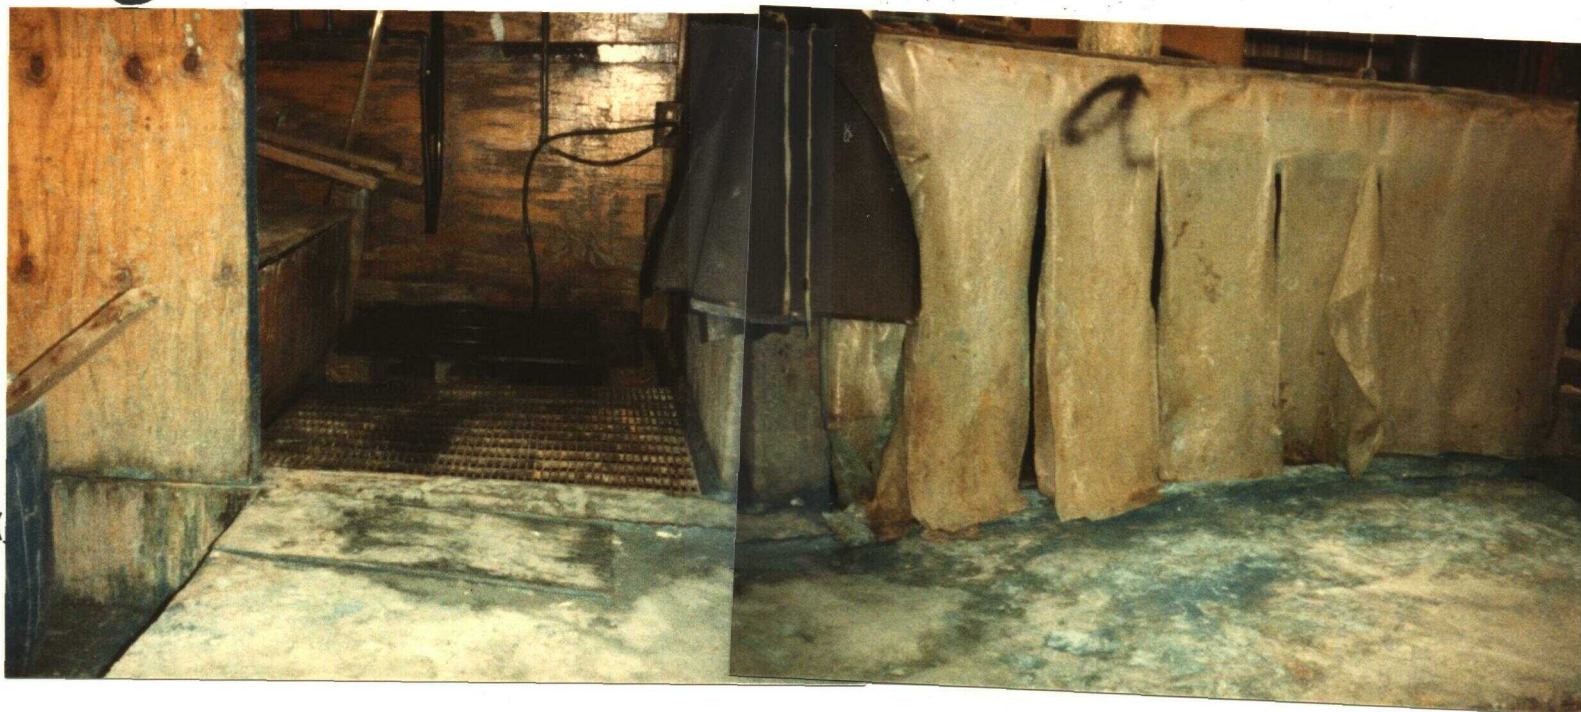
②

TWO CONCRETE SINS INSIDE PROCESS WAREHOUSE

SURFACE IMPOUNDMENTS SITE INSPECTION REPORT (Supplemental Report)		INSTRUCTION Answer and Explain as Necessary.
1. TYPE OF IMPOUNDMENT Two concrete basins for the washing/rinsing of low and empty drums containing ammoniated copper etching solutions.

16. OTHER EQUIPMENT - splash guards - see photo No. 2

Comments: Drum washing basin
and rinse sump (inside process
building)

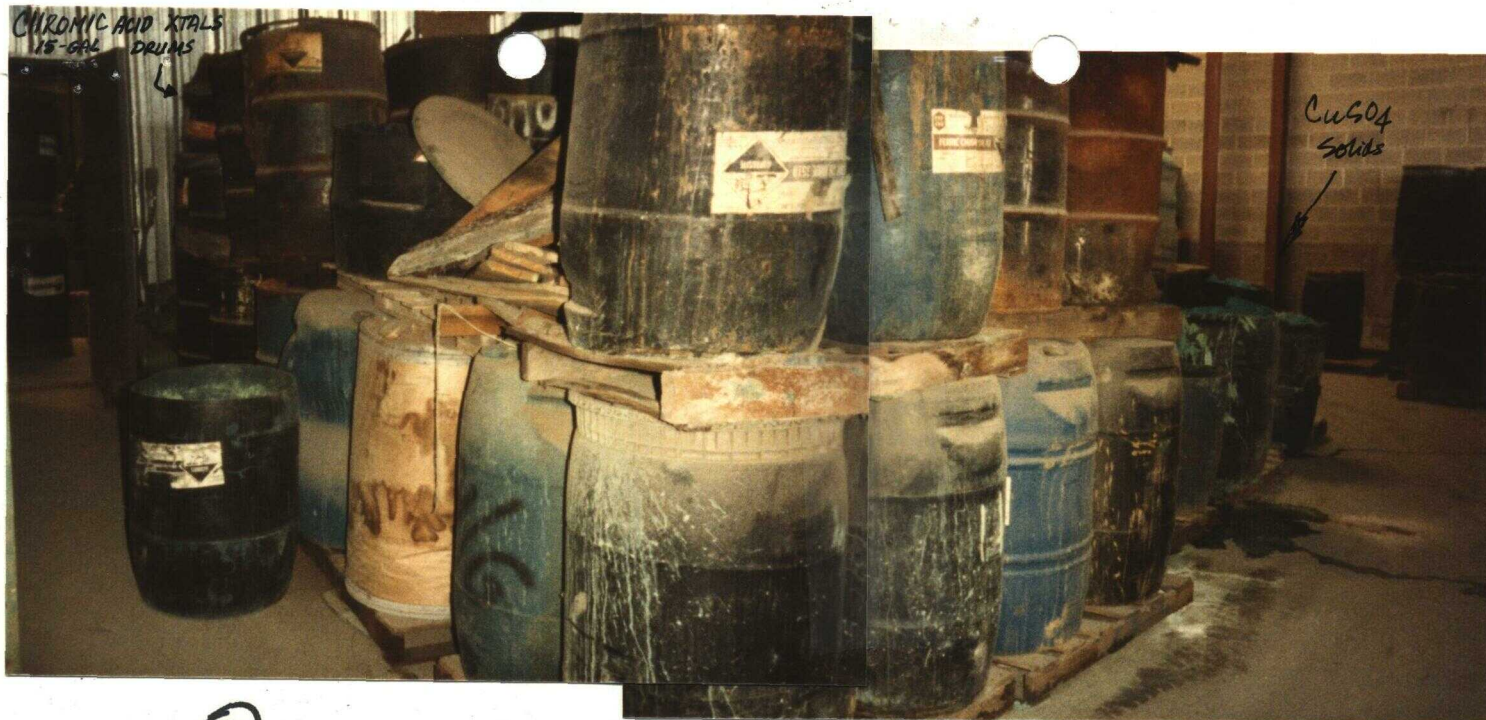
③

Some leakage of Copper Chloride/Copper Sulfate solutions from barrels was apparent (see photo No.3), but Chromic acid crystals were contained.

Comments: Discarded Drum storage
Area; some drums in bkgd
contain ~~Chromic~~ Chromic Acid crystals
pending disposal off-site.

Two areas of concern are the presence of about 15 small drums of chromic acid crystals yet to be disposed and minor seepage of process solvent to the outside paved area. A low hazard assessment has been given to the site.

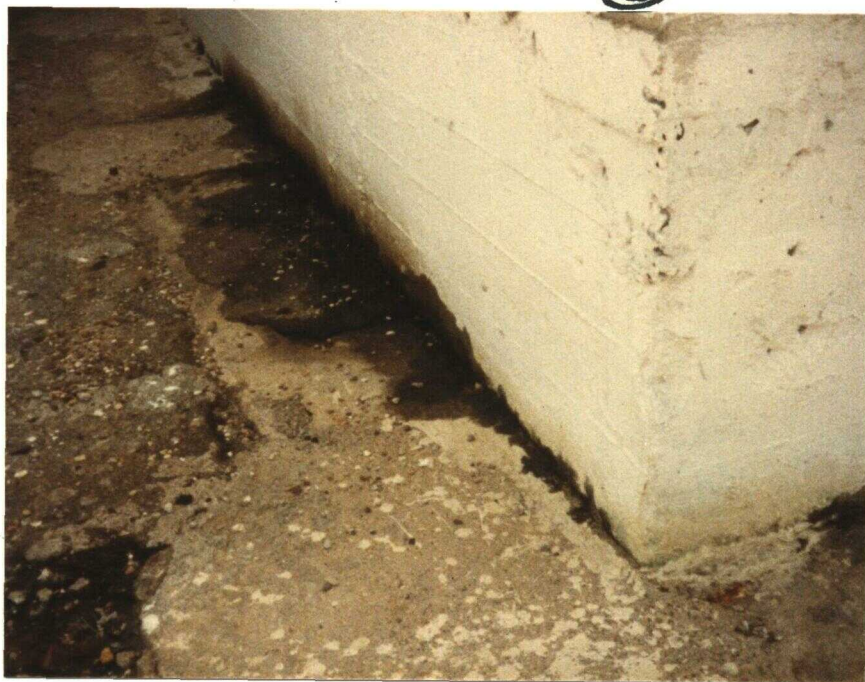
⑤

Comments: Apparent solvent seepage
from LIX process bldg. Sump
for spillage is located on other
side of wall.

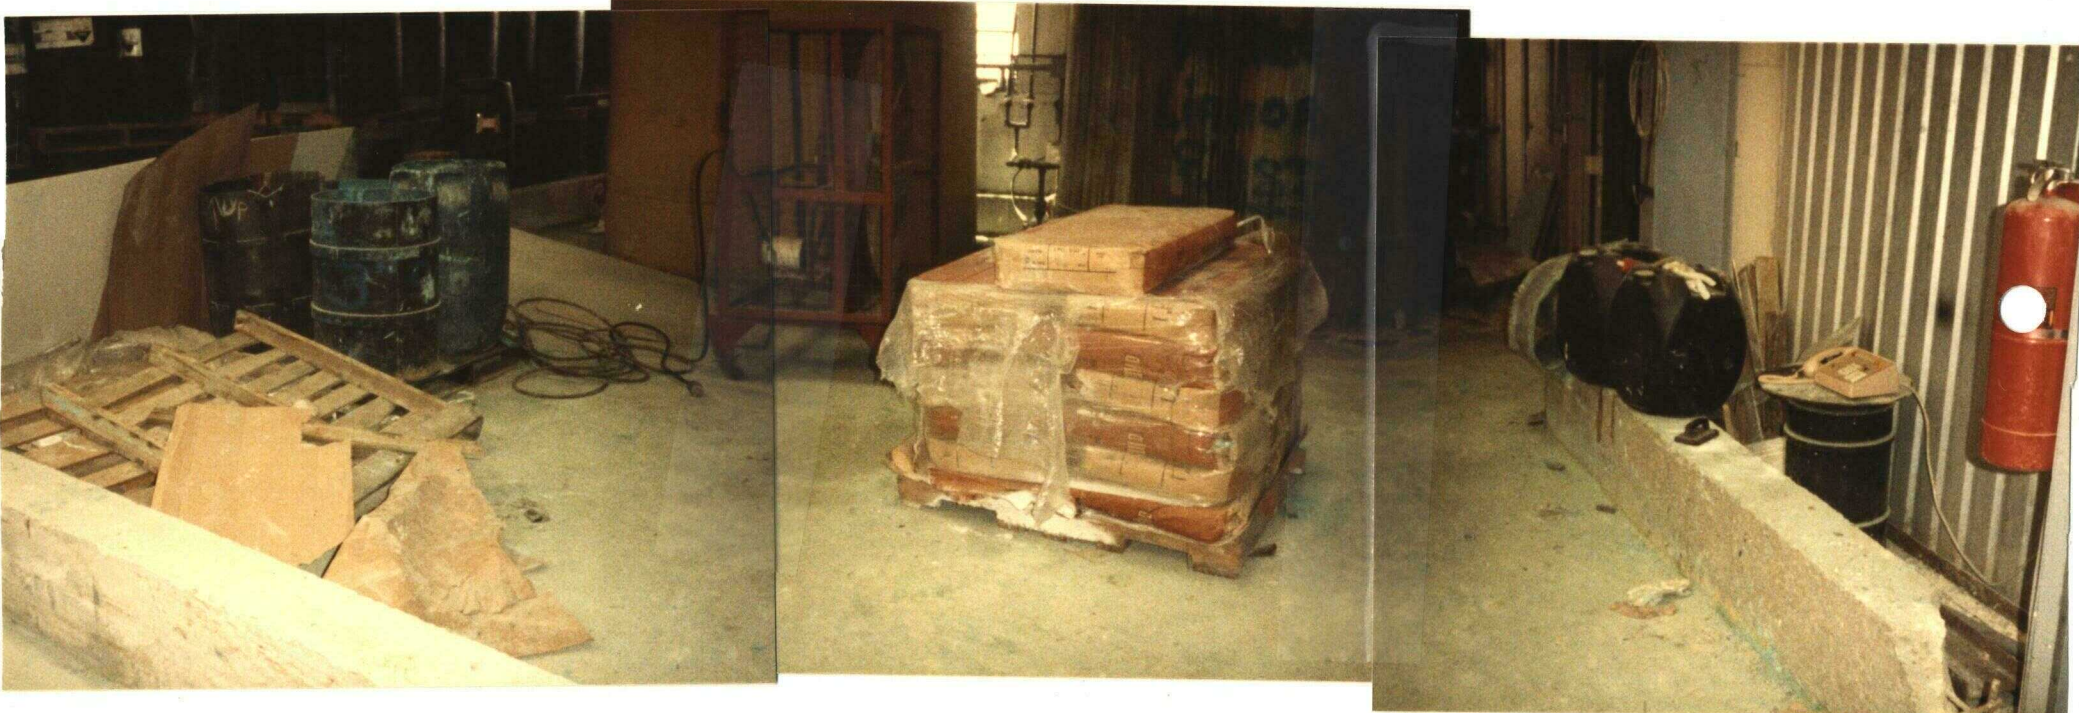
④

The former drum storage area for spent acidic etchants (chromium-bearing) was observed next. This diked area was inside the warehouse and presently contains CuSO_4 solution tanks but no drums (Photo No. 4).

Comments: Diked area once
used for drum storage of acidic
and chromium-bearing wastes
prior to offsite disposal

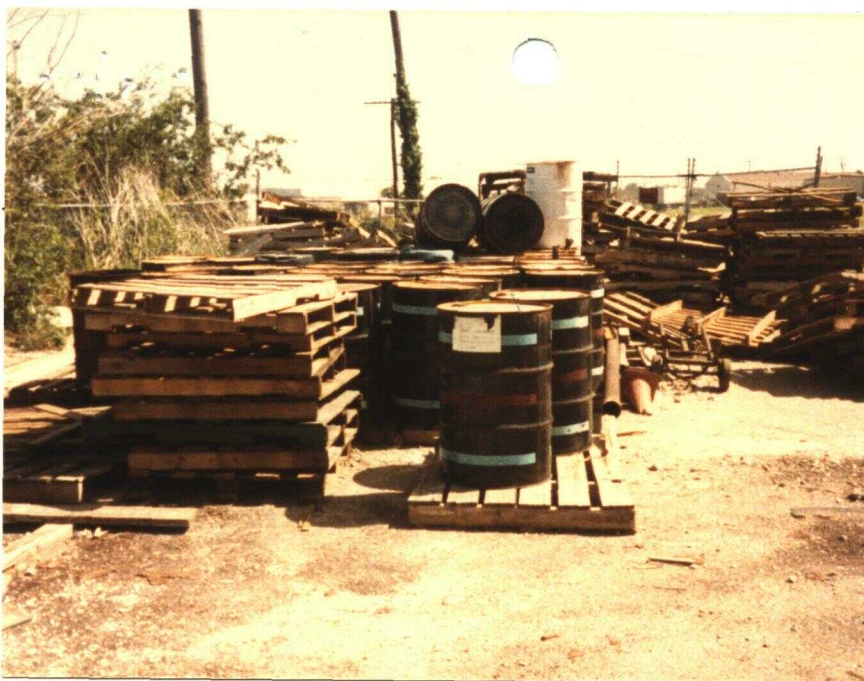
②

No spillage or leakage was noted around the outside kerosene drum storage area. The property on the NE corner of the site was heavily vegetated and built up about 3'. Site drainage appeared to be northeastward along the east fence line. A soil sample was collected in the runoff path which showed a two-fold increase of total chromium and a two hundred-fold increase of copper over background levels. The pH of the soil was found to be neutral to mildly alkaline (7.8).

Comments: Outside Drum Storage
for kerosene solvent (raw mat'l)
and pallets. No spillage or
leakage apparent.

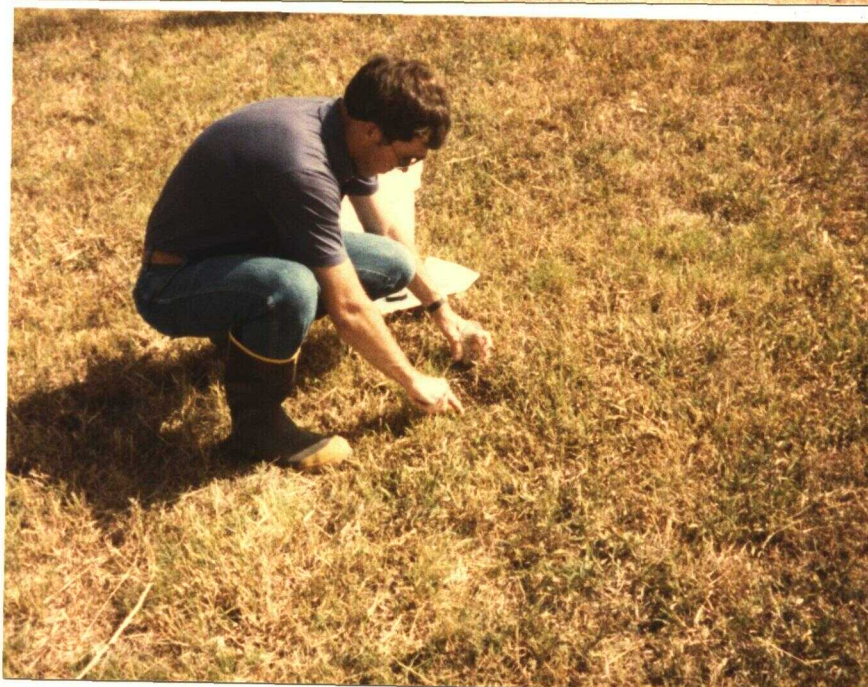
⑦

Comments: Collection of bled
soil sample
